Project: 14902 ITD Date Received: November 25, 2013
P.O. Number: _____ Date Reported: November 25, 2013

Asbestos Bulk Sample Analysis Report

DRAWING NO. 10
SERVICE MAINTENANCE SHOP
BUILDING NO. 6093
RIGBY, IDAHO

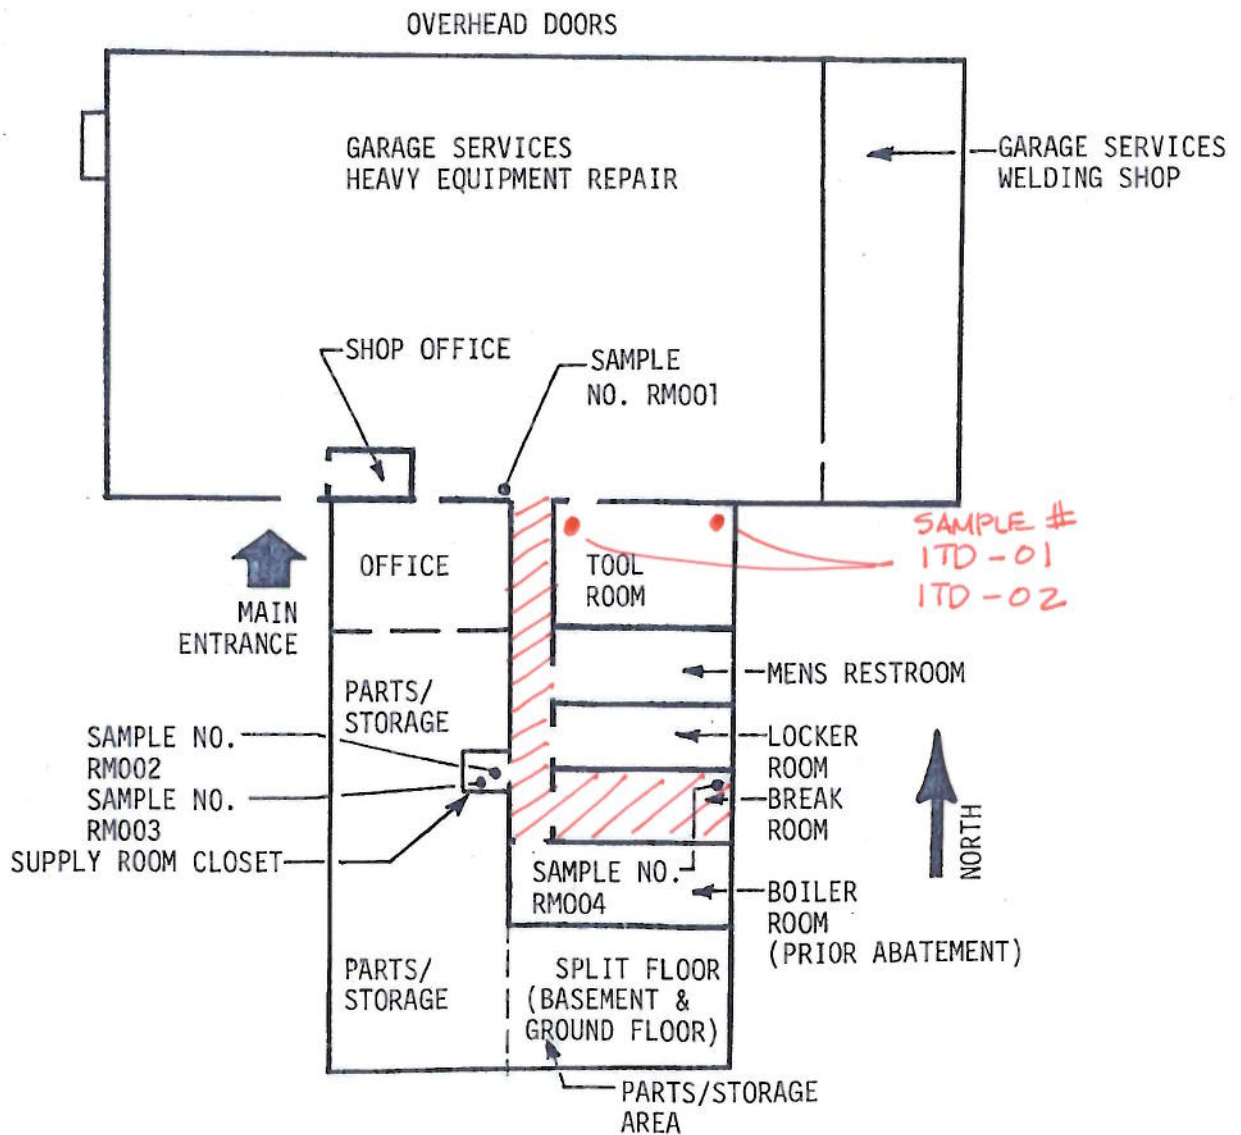
SAMPLE NUMBER	LAB NUMBER	SAMPLE TYPE, LOCATION, and DESCRIPTION	% ASBESTOS FIBERS	% NON-ASBESTOS FIBERS	% NON-FIBROUS MATERIALS	COMMENTS
ITD-01	B113056	Floor tile and mastic - tan hard compact granular with fibers	2% Chrysotile		5% Mastic 93% Other	AFT @ 2%, AFM @ 5%
ITD-02	B113057	Floor tile and mastic - tan hard compact granular with fibers	2% Chrysotile		5% Mastic 93% Other	AFT @ 2%, AFM @ 5%

AREA OF REMOVED FLOORING TILES
